**Fractured Canine Tooth**

**Root Canal Therapy**

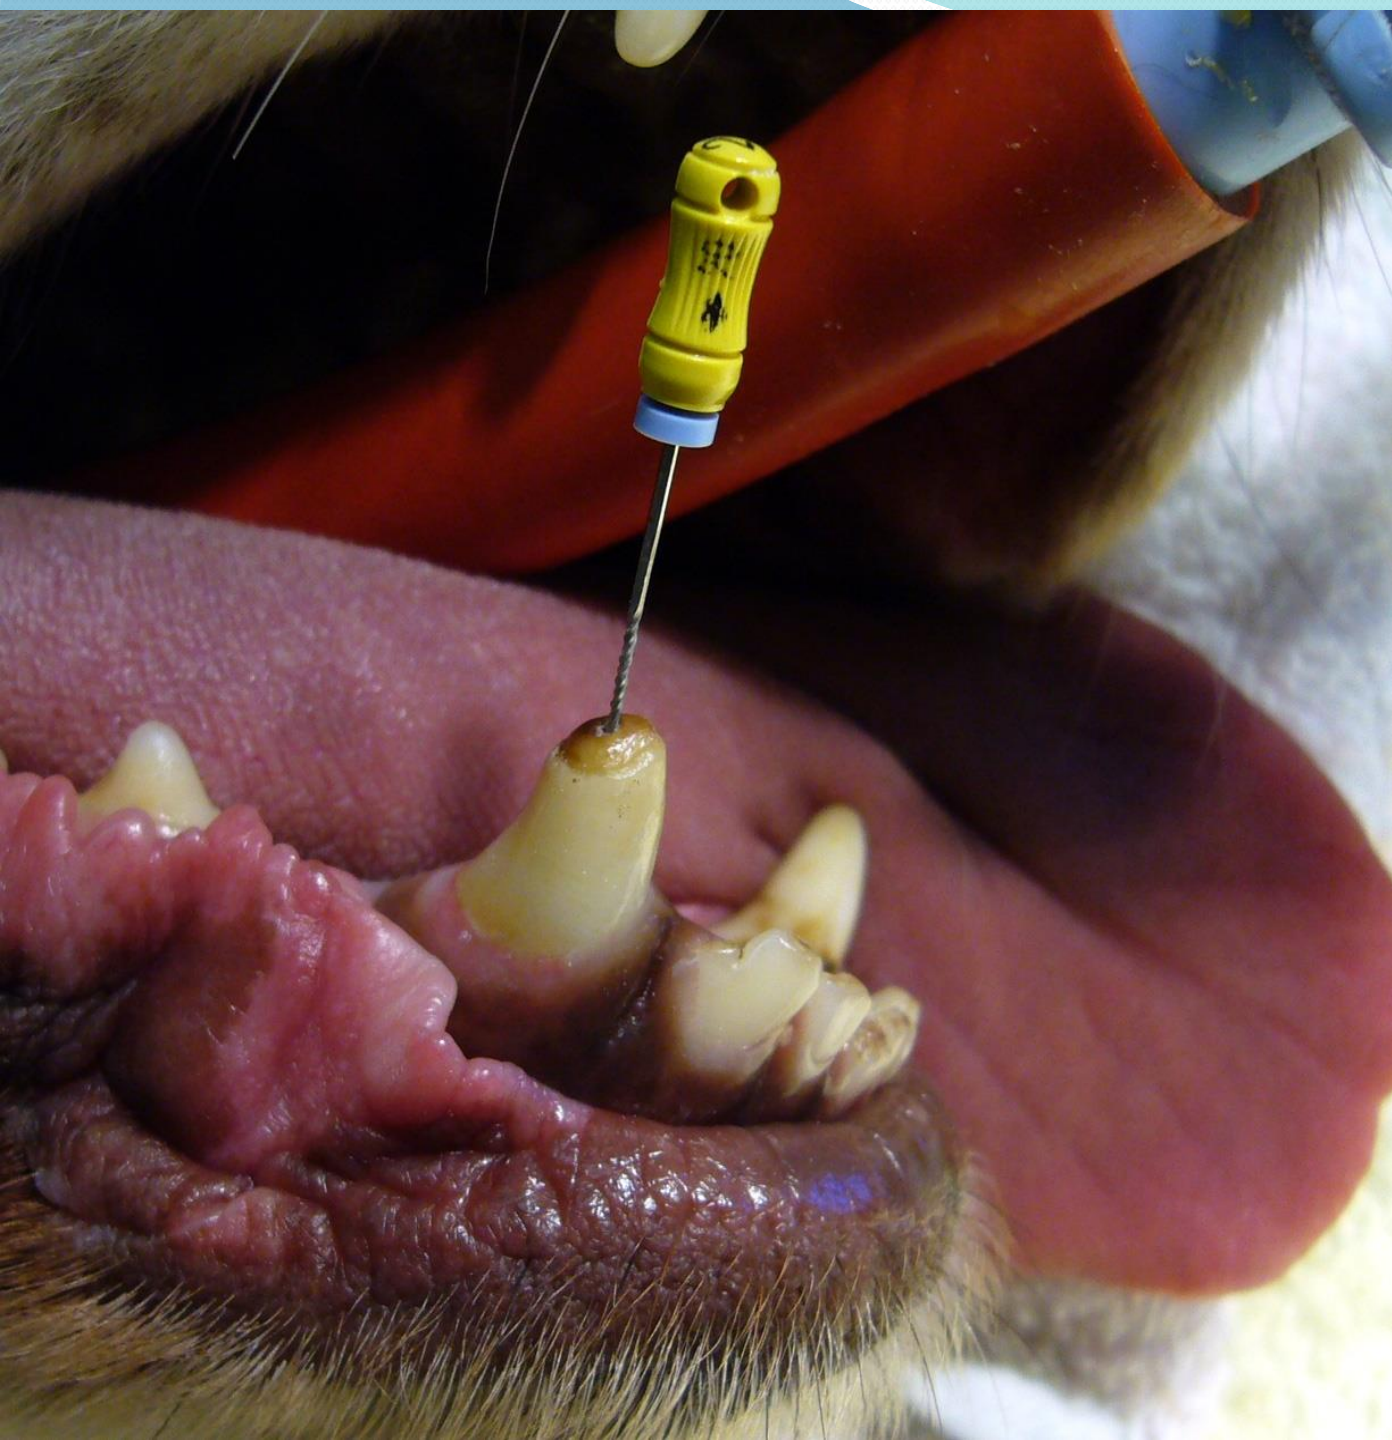
**Fractured  
right lower  
canine  
with  
file in  
open pulp  
access**

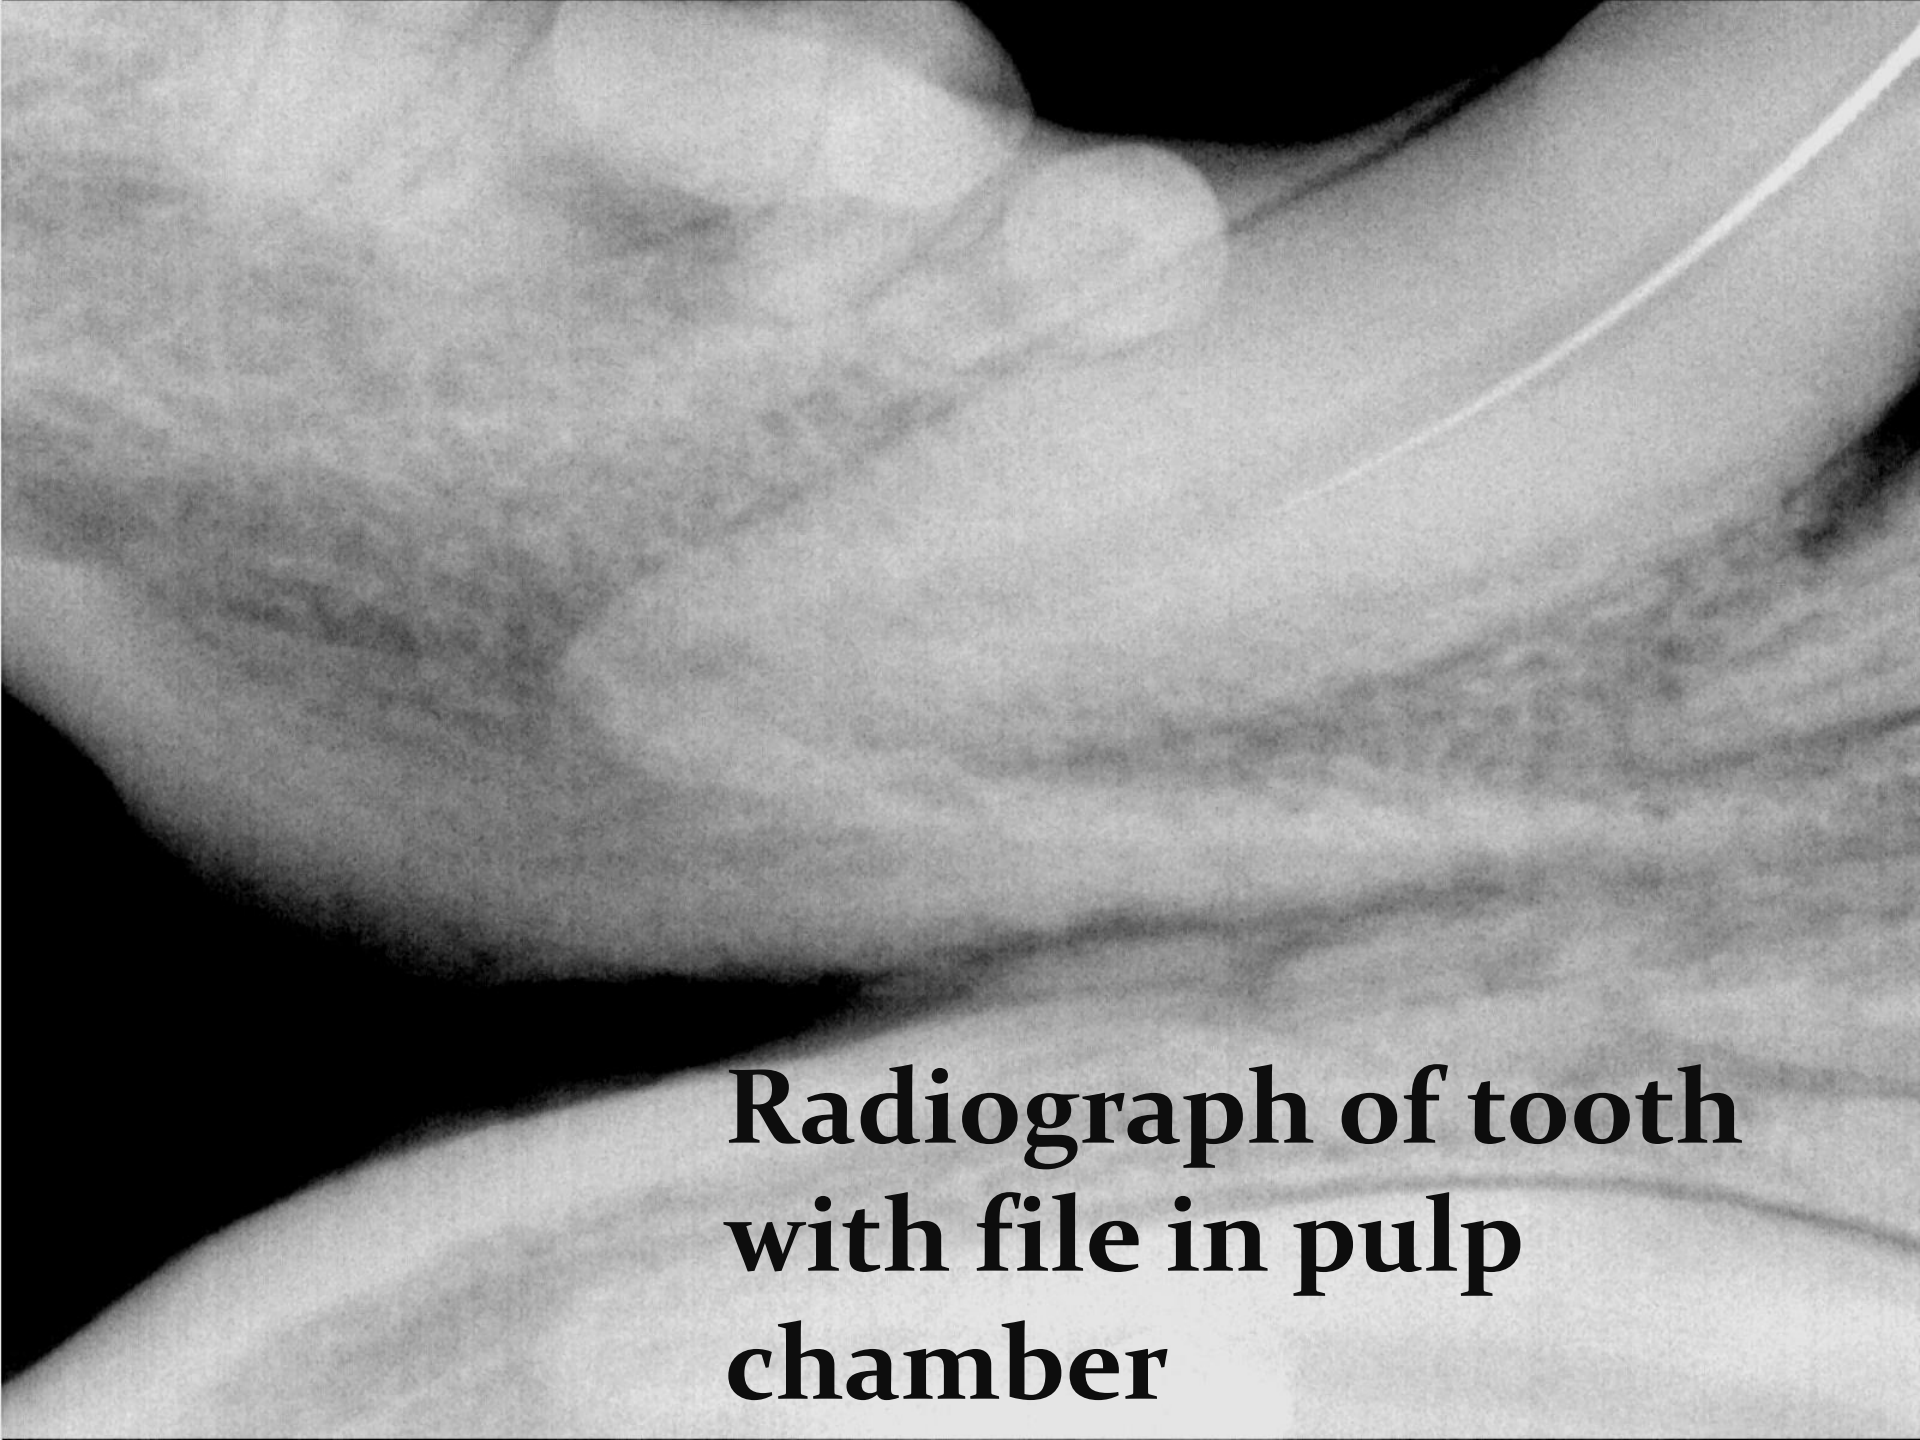
A black and white radiograph of a tooth. The image shows the internal pulp chamber and root canal. A thin, dark line representing a file is visible within the pulp chamber. The surrounding bone and soft tissue are shown in various shades of gray.

**Radiograph of tooth  
with file in pulp  
chamber**

A close-up, grayscale photograph of a dental root canal. A white, cylindrical file is inserted into the canal, extending to the bottom. The canal walls are visible, showing some texture and a slight curve. The background is dark, making the white file and canal stand out.

**Largest file to reach  
the full working  
length of root canal**

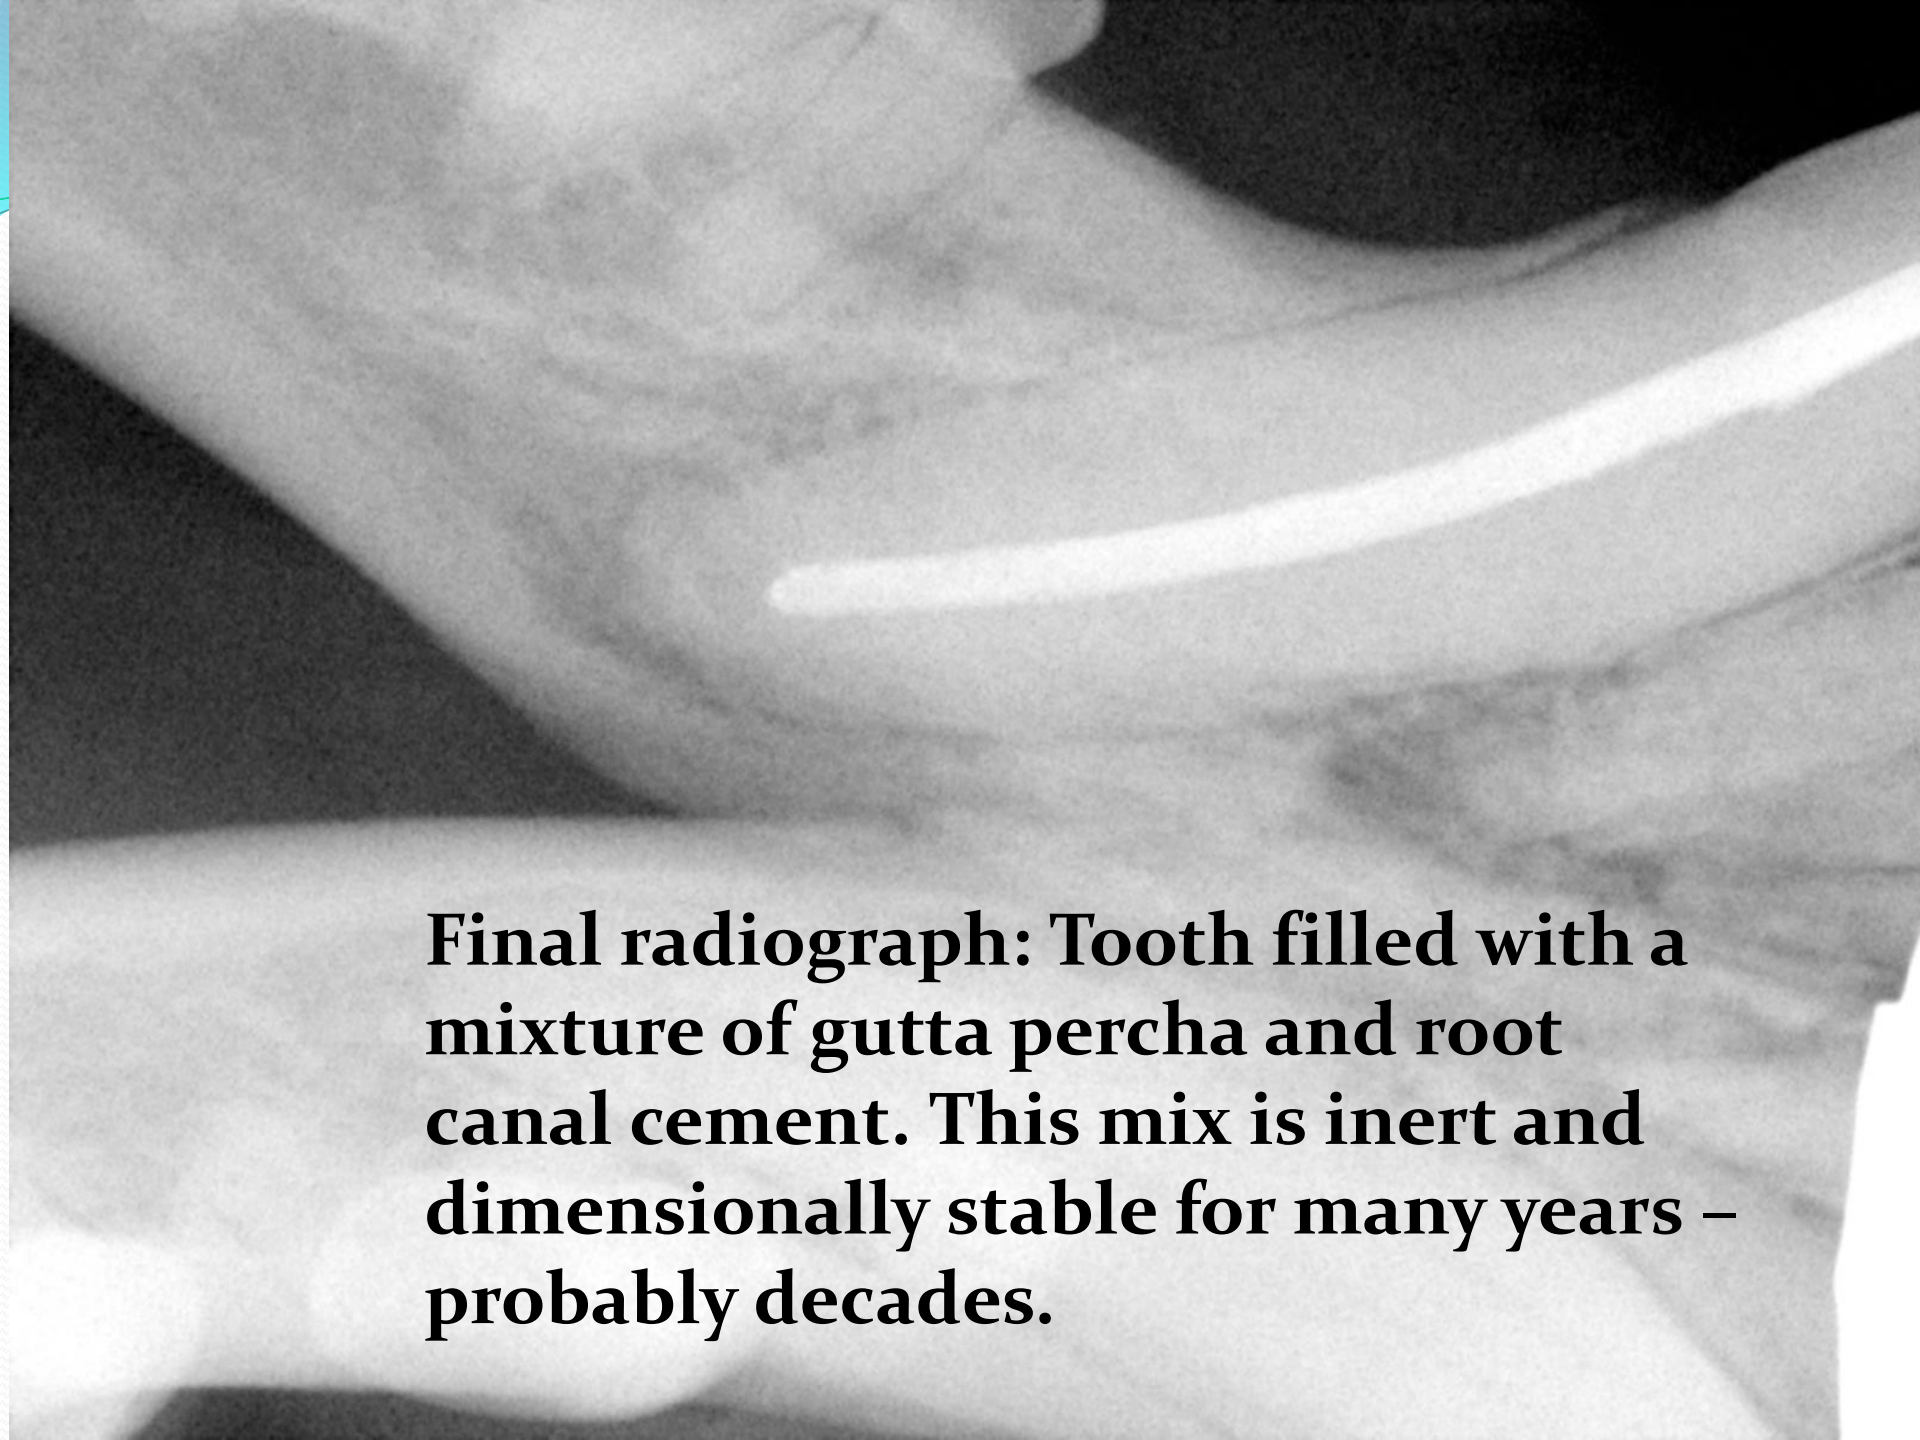
**Final radiograph: Tooth filled with a mixture of gutta percha and root canal cement. This mix is inert and dimensionally stable for many years – probably decades.**
